**National Highway  
Traffic Safety  
Administration**

Case Vehicle (A): 1999 Chevrolet  
Type: Venture 4 x 2, 4-door APV  
Driver: 18-year-old male  
CDC: 12-FREE-5, 09-LZAW-4

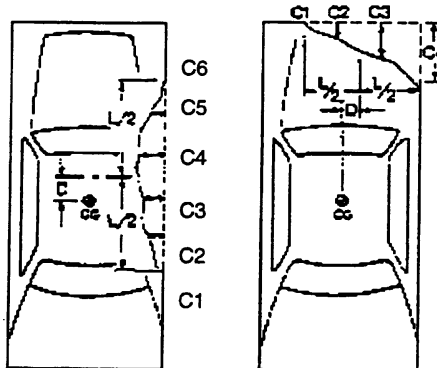
DL 28  
UDL 132

Specific Impact Number	Plane of Impact C-Measur.	Direct Damage		Field L	C <sub>1</sub>	C <sub>2</sub>	C <sub>3</sub>	C <sub>4</sub>	C <sub>5</sub>	C <sub>6</sub>	±D
		Length (DDL)	Max Crush								
1	1	28	72	112	6	9	15	26	36	72	+66
-	Free space		-13		-13	-4	-1	-1	-4	-13	
1	1	028	059	112	000	005	014	025	032	059	+066
13	14	15 16 17	18 19 20	21 22 23	24 25 26	27 28 29	30 31 32	33 34 35	36 37 38	39 40 41	42 43 44 45
2	4	116	45	192	0	9	16	29	14	0	-96
	4							45			
	Average							37			
2	4	116	045	192	000	009	016	037	014	000	-096
